MEMORANDUM

January 25, 2001 Meeting

Solutia, Inc. ILD000802702

W. G. Krummrich Plant Incident No. [0101]

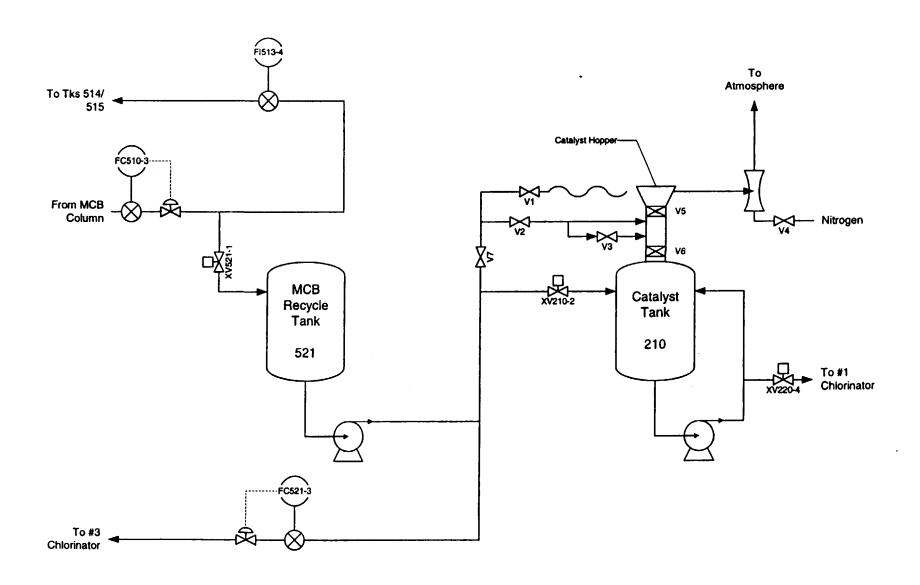
Figure 1: Simplified Piping and Instrument Diagram - MCB Recycle Tank and Catalyst Tank

On Sunday, January 7, 2001, a flush valve was left open following a routine catalyst addition procedure. As a result, monochlorobenzene (MCB) filled the catalyst addition hopper, and subsequently overflowed to the pad below the Catalyst Tank (Item 210). The MCB flowed into the department's area drain. While some of the material reached the Collection Sump and was pumped to the Rainwater Tank (Item 947), most escaped the area drain/sump system to the ground around the Collection Sump area.

Causes:

1. The catalyst addition procedure was not followed.

3. There was a deterioration of the seal of the outgoing joint at #4 junction box in the pump alley north of the Collection Sump.
